EXPERIMENTAL INVESTIGATION OF AIR-COOLED TURBINE BLADES  
IN TURBOJET ENGINE

XIII - ENDURANCE EVALUATION OF SEVERAL PROTECTIVE  
COATINGS APPLIED TO TURBINE BLADES OF  
NONSTRATEGIC STEELS

6817  
NACA RM E53E18

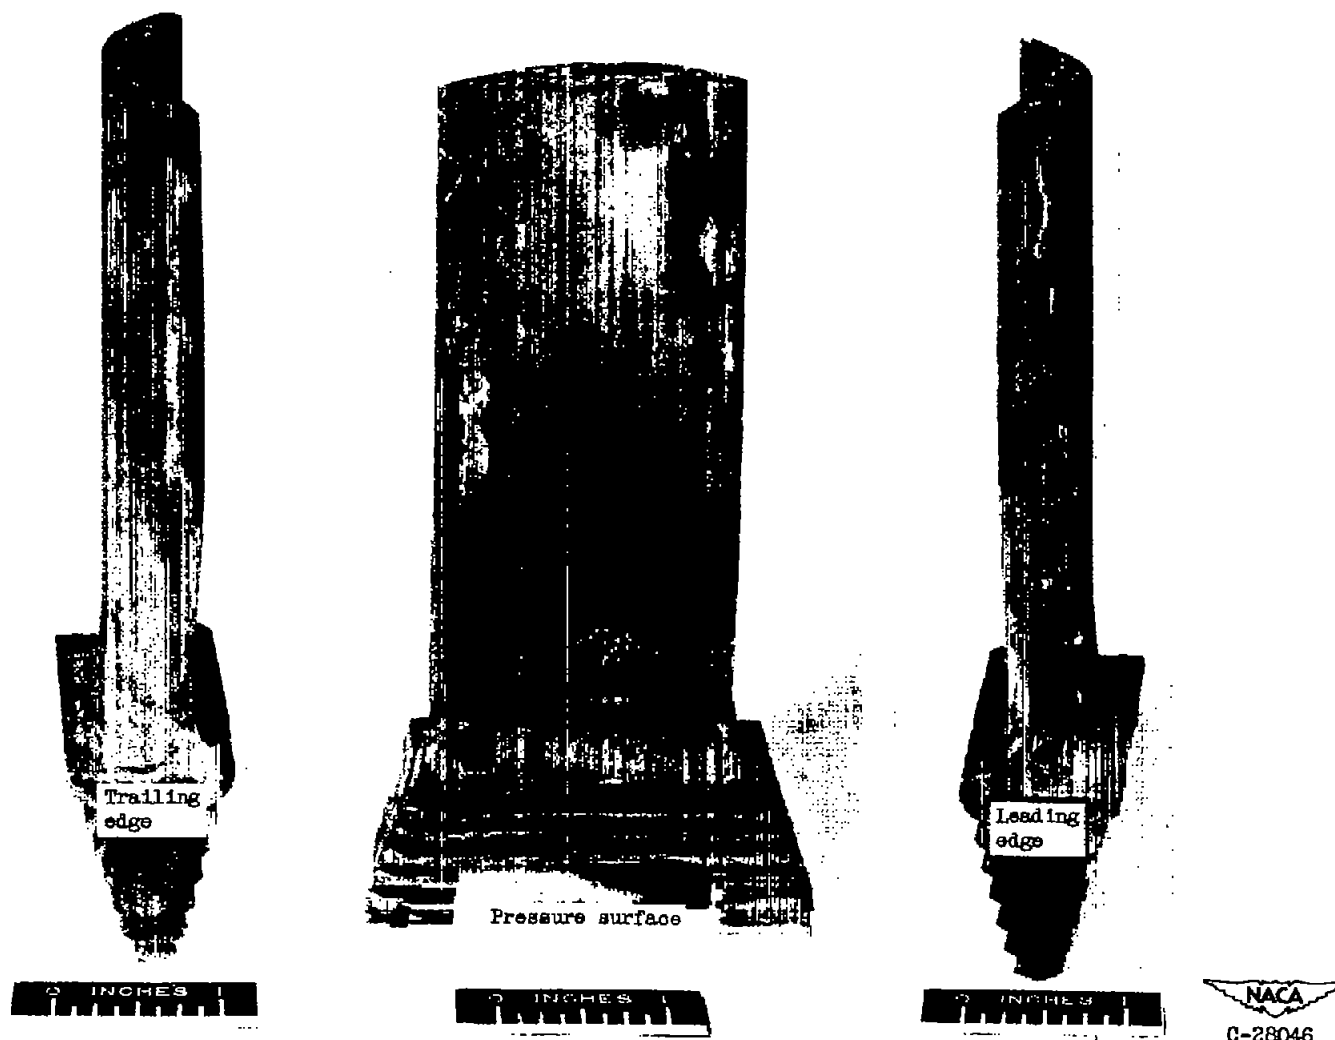
Blade 1. - The coating on blade 1 was considered a failure after 7.3 hours of rated engine speed operation, and investigation of the blade was concluded at the end of that time. Figure 3(a) shows several views of the blade at the conclusion of the tests and it can be seen that the coating chipped away from the leading- and trailing-edge regions of the blade. There is also an area near the root in the midchord region of

the blade where the coating flaked off. The failure of the coating apparently was a function of the metal temperature, as the greatest damage to the coating occurred at the leading- and trailing-edge regions where the metal temperatures are the highest (see fig. 2). More coating was removed from the leading edge than from the trailing edge, probably because the high-velocity combustion gases impinge directly upon the leading edge and their erosive action is greatest in this area.

(a) Blade 1 after 7.3 hours (20 cycles plus 2.3 hours at rated test conditions) with coolant-flow ratio of 0.048. Complete breakdown of coating along leading and trailing edges evident.

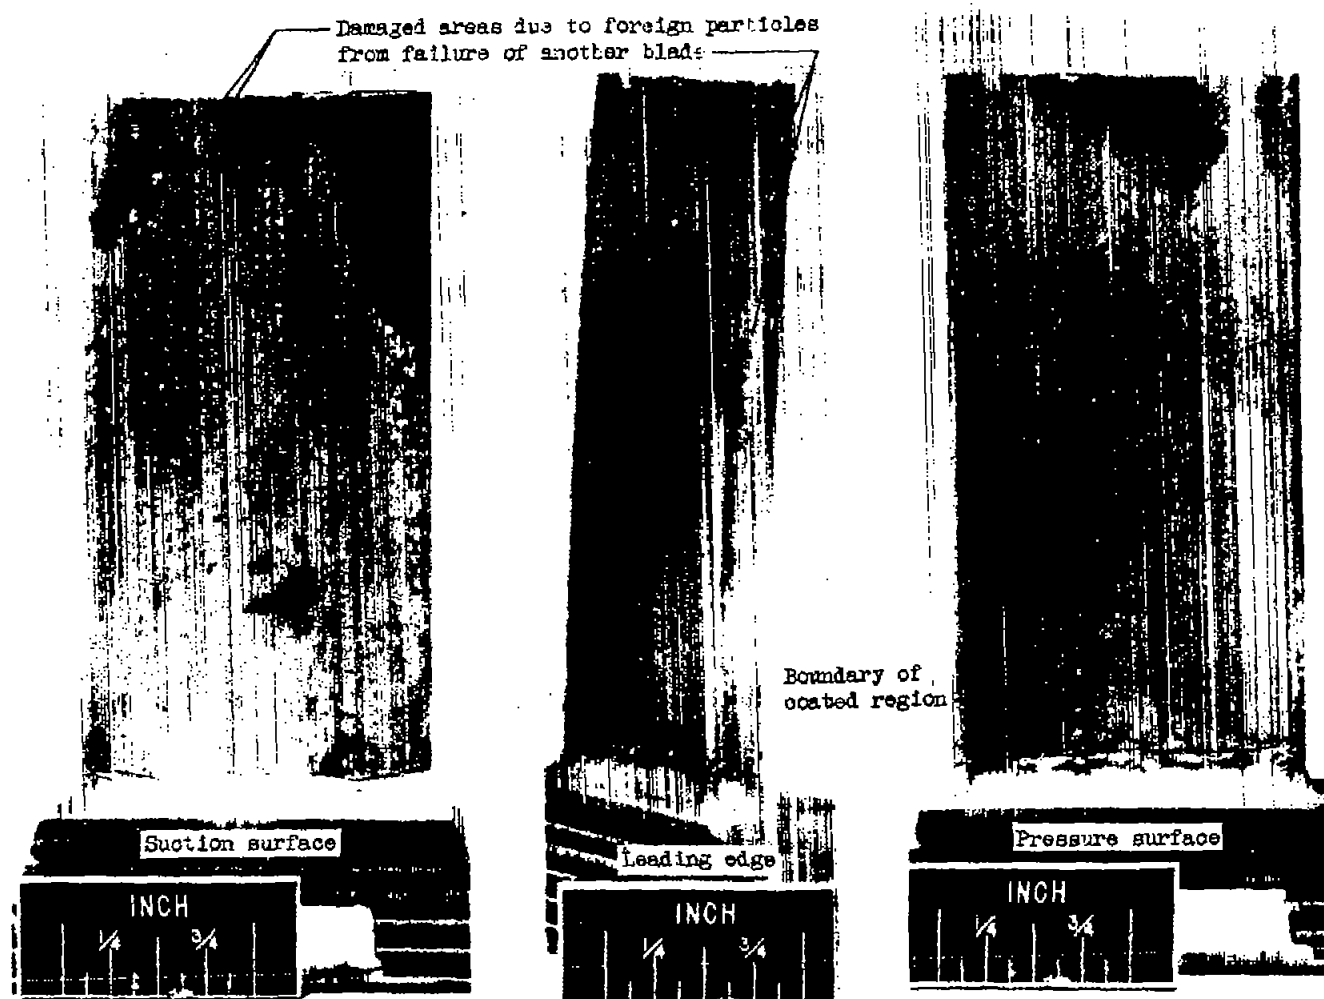
the blade was chipped off and bare metal appeared to be exposed. Operation was continued, however, and after 34.3 hours the blade was again struck by a foreign object and damaged in about the same area as previously. This damage can be seen on the leading edge of the blade in figure 4(a). Several smaller chipped areas were observed in the coating on the forward portion of the suction surface near the blade tip and can also be seen in figure 4(a). Investigation of the coating was continued until the blade was operated for 100 hours at rated test conditions. Figure 4(b) shows the blade upon completion of 100 hours of operation. (The damage to the coating along the trailing edge of the blade which is visible in the view of the pressure surface in fig. 4(b) was caused by mishandling of the blade after completion of the tests.) Microscopic examination of a section through the damaged area at the leading edge indicated that some ceramic still clung to the metal and apparently provided complete corrosion protection since no corrosion could be observed under the microscope. During the investigation of blade 5 no softening or flowing of the coating was observed. No chipping or flaking other than that caused by foreign particles passing through the turbine was observed. Slightly raised markings that became evident on the surface of the coating after heat treating were still visible after 100 hours of running, indicating that the coating had not eroded to any great extent. After 100 hours of operation the coating was in excellent condition except where it had been hit and appeared to provide complete protection for the blade shell even in those areas. Corrosion was observed on the uncoated inner surfaces of the shell and on the cooling-air tubes to depths of 0.003 to 0.005 inch. These observations were made in the immediate vicinity of the leading edge.

(a) Blade 5 after 34.3 hours at rated test conditions with coolant-flow ratio of 0.048. Coating in excellent condition except where damaged by foreign objects striking blade.

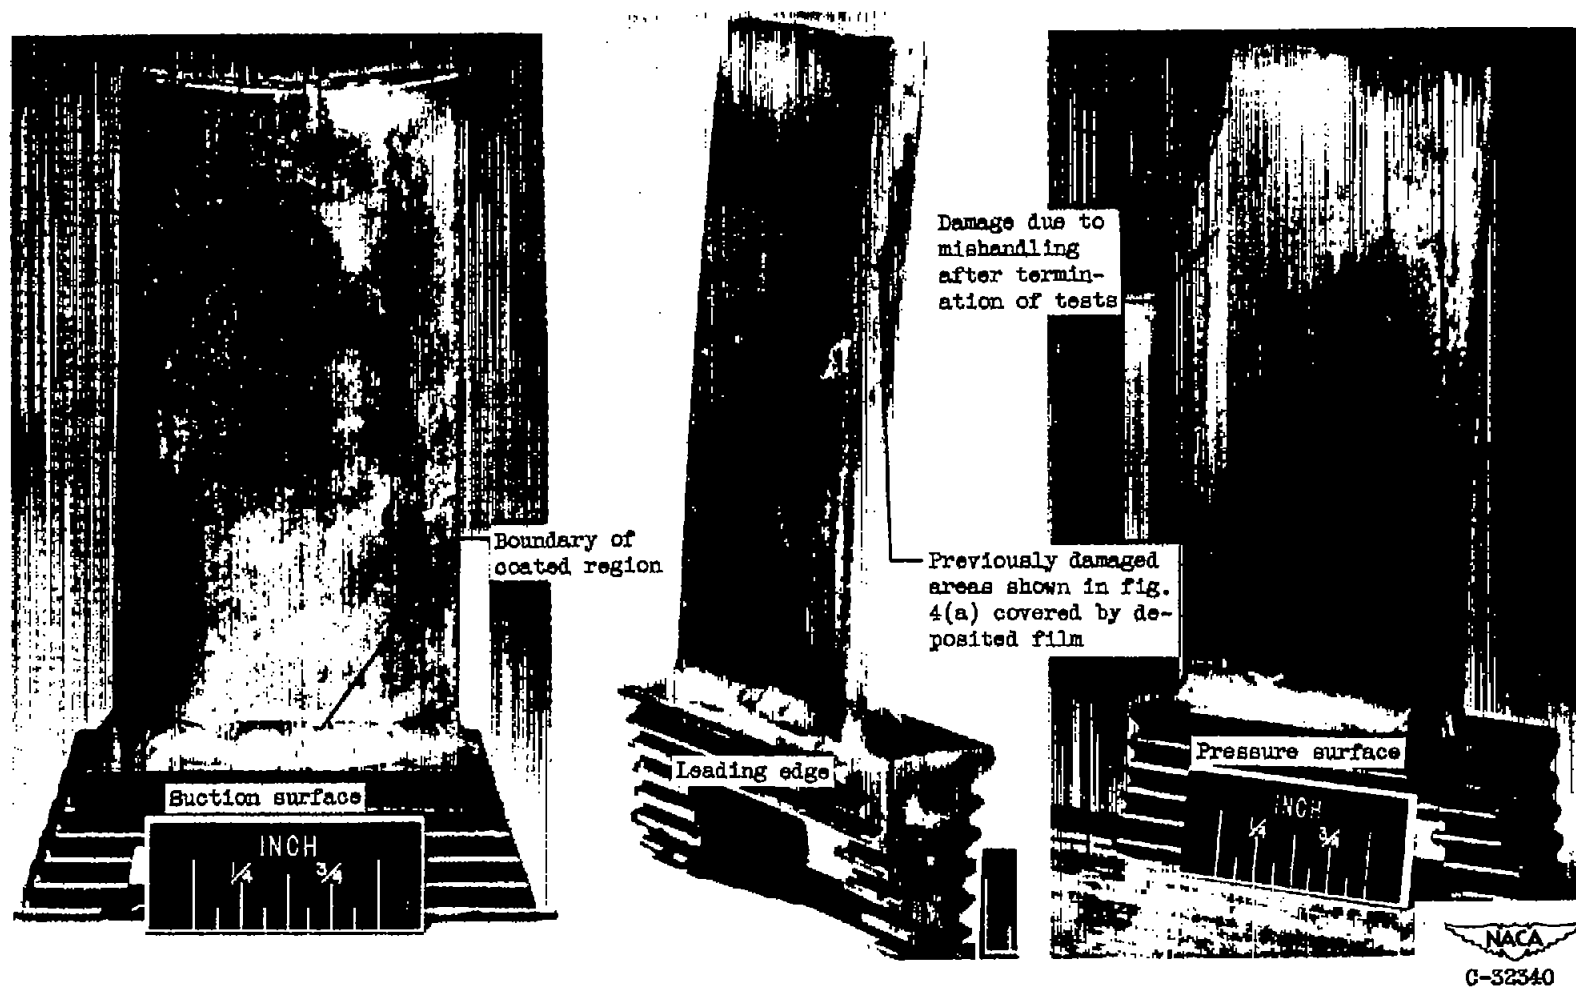
(b) Blade 5 after 100 hours at rated test conditions with coolant-flow ratio of 0.048. Coating in excellent condition except where hit by foreign objects.

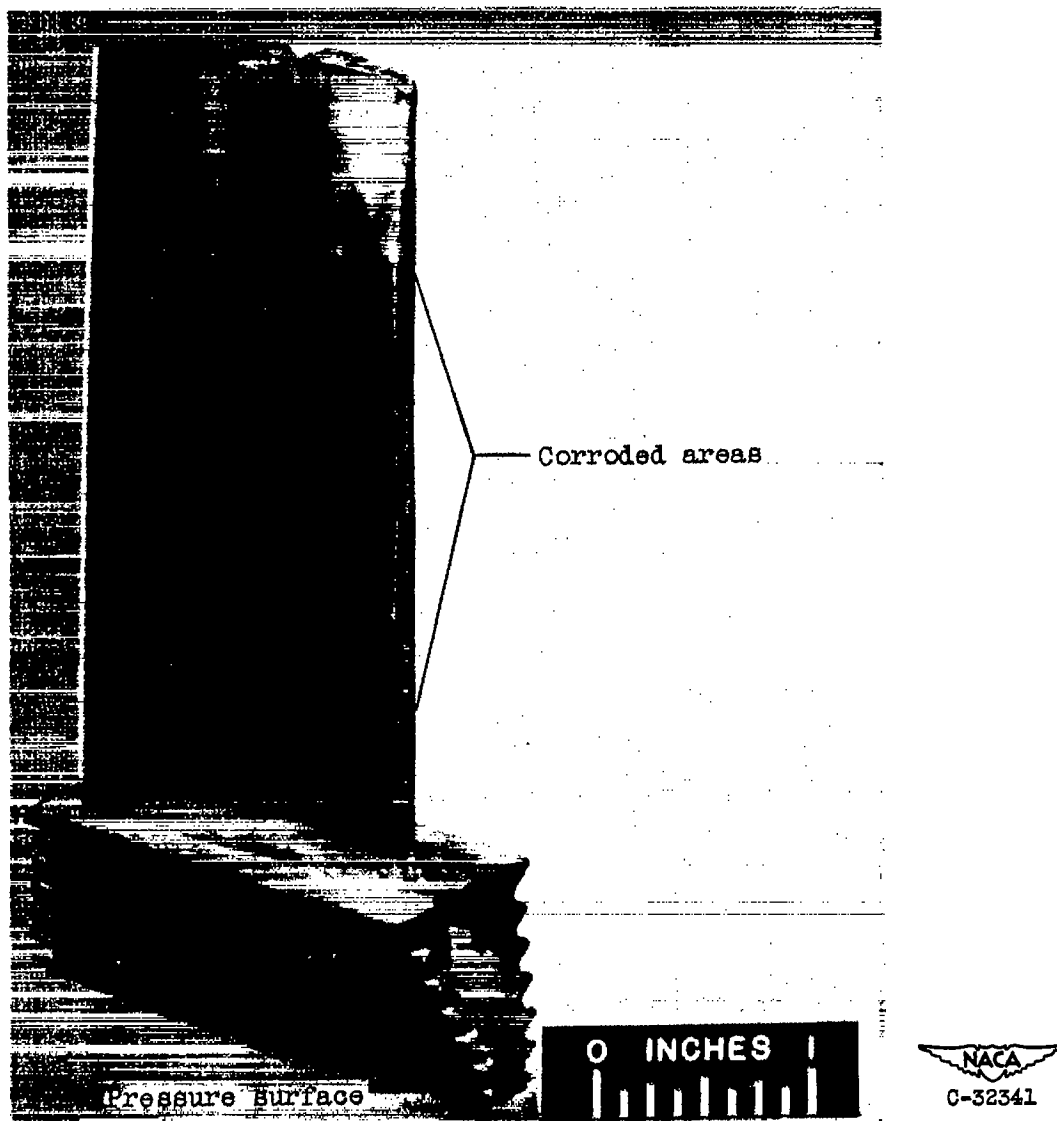
Blades 6, 8, 9, 11, 12, 14, and 15 were operated at rated test conditions for periods of time ranging from about 11.5 hours to as much as 25 hours before the coatings were considered failures. The failures of the nickel coatings were all similar, that is, the nickel began to blister and chip away from the leading- and trailing-edge regions of the blades as shown in figure 5(a). As operation of the blades was continued, corrosion of the parent metal in the leading and trailing edges occurred and the nickel coating also began to fail in the midchord region of the blade. The coatings generally began to fail first in the tip region of the blade after about 11 to 15 hours of rated engine speed operation. Temperature and centrifugal force are both factors in the breakdown of the coating. Failure usually progressed rapidly along the leading edge of the blade, where erosion also seemed to be a factor in removal of the coating. A blade that exhibited extensive erosion and corrosion at the leading edge is shown in figure 5(b), which is a photograph of blade 6 at the completion of 44 hours at rated test conditions. The failure of the coating along the trailing edge was generally less extensive than that at the leading edge, probably because the scouring action of the combustion gases is not so great in this region. Also, trailing-edge temperatures are somewhat lower than those at the leading edge. The temperature level of the blade material influences the life of the nickel coating; failure of the coating in the cooler midchord region was much more infrequent than at the leading and trailing edges (see fig. 2). Frequently, no evidence of failure was observed in the midchord region. The lower temperature apparently enables the nickel to adhere and provide the necessary corrosion resistance.

(a) Blade 12 after 55.3 hours at rated test conditions with coolant-flow ratio of 0.03 to 0.048. Coating completely eroded away at leading edge and blistered and flaked in scattered areas over entire blade.

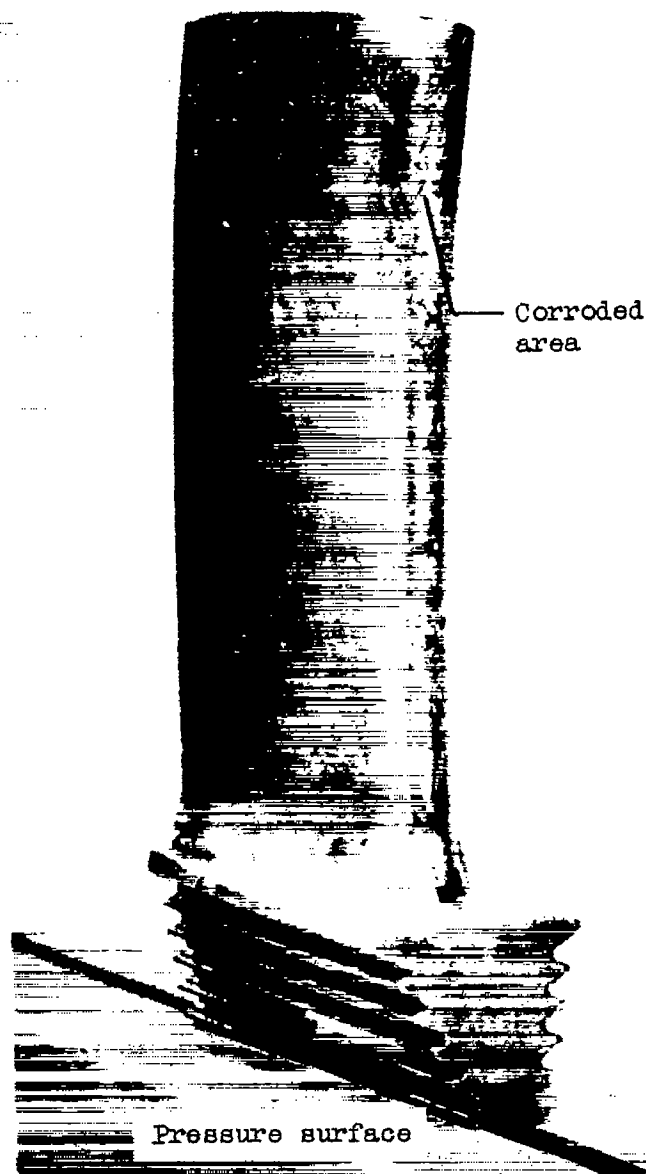
(b) Blade 6 after 44 hours at rated test conditions with coolant-flow ratio of 0.048. Coating chipped and eroded on leading edge and eroded along trailing edge. Leading edge corroded near tip.

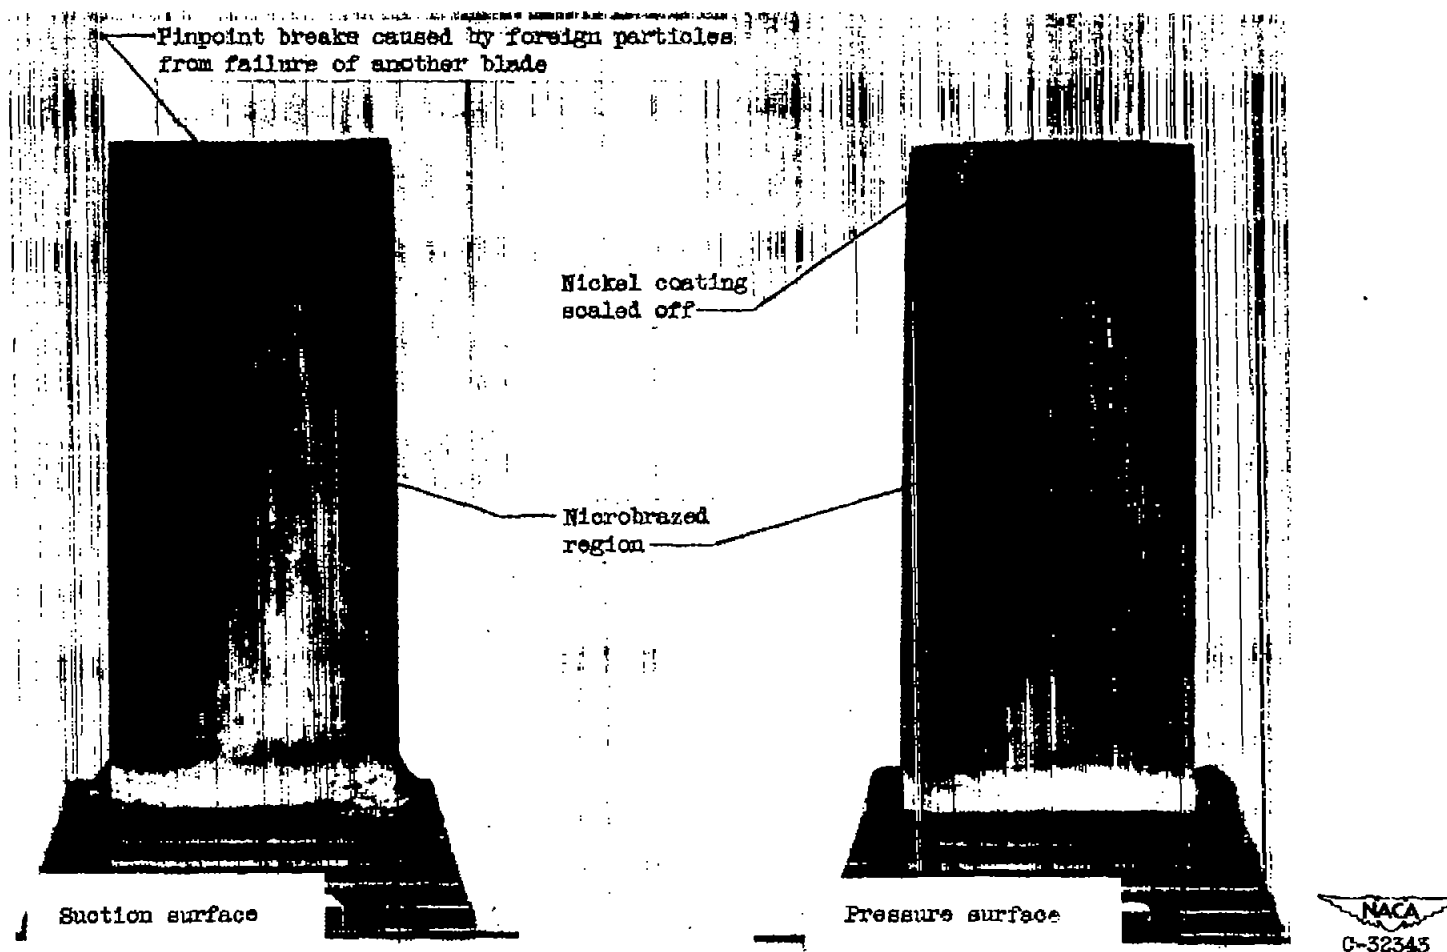
Figure 6. - Nickel-coated blade 20 with Microbraz along leading edge. Blade after 100 hours at rated test conditions with coolant-flow ratio of 0.048. Leading edge and midchord region in excellent condition.

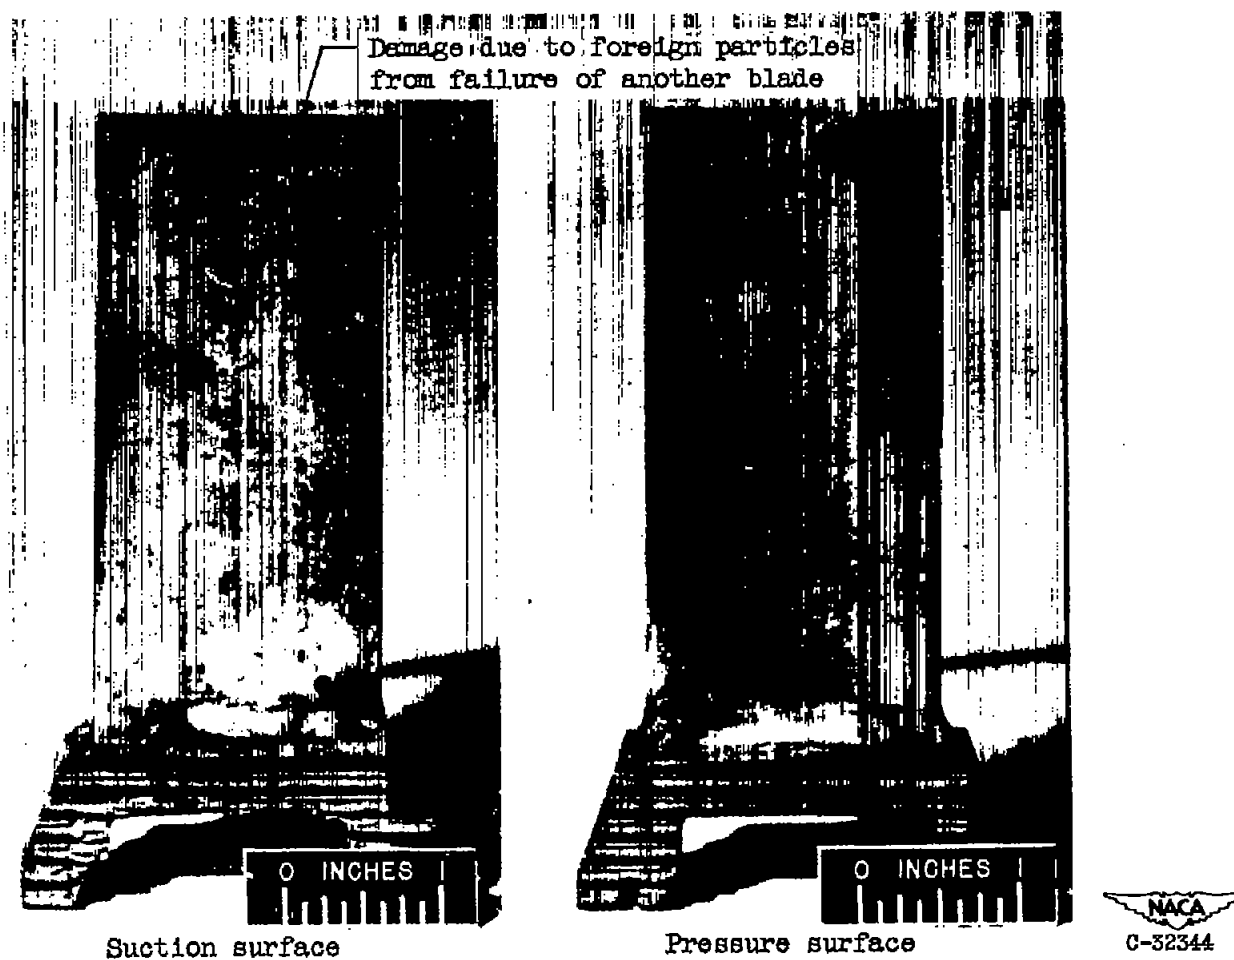
The suction surface of blade 24 was struck by fragments of a failed blade after 50 hours of operation and a number of shallow scratches resulted (see fig. 7(a)). The aluminized layer was sufficiently tough to withstand the impact and no damage was sustained other than the scratches themselves. Upon further running the scratches disappeared and were presumably filled in by iron-aluminum compounds from the adjacent surfaces. The surface of the blade after an additional 50 hours of operation showed no traces of the damage (see fig. 7(b)).

(a) Blade after 50 hours at rated test conditions with coolant-flow ratio of 0.048. Blade surfaces in excellent condition except where hit by foreign particles.

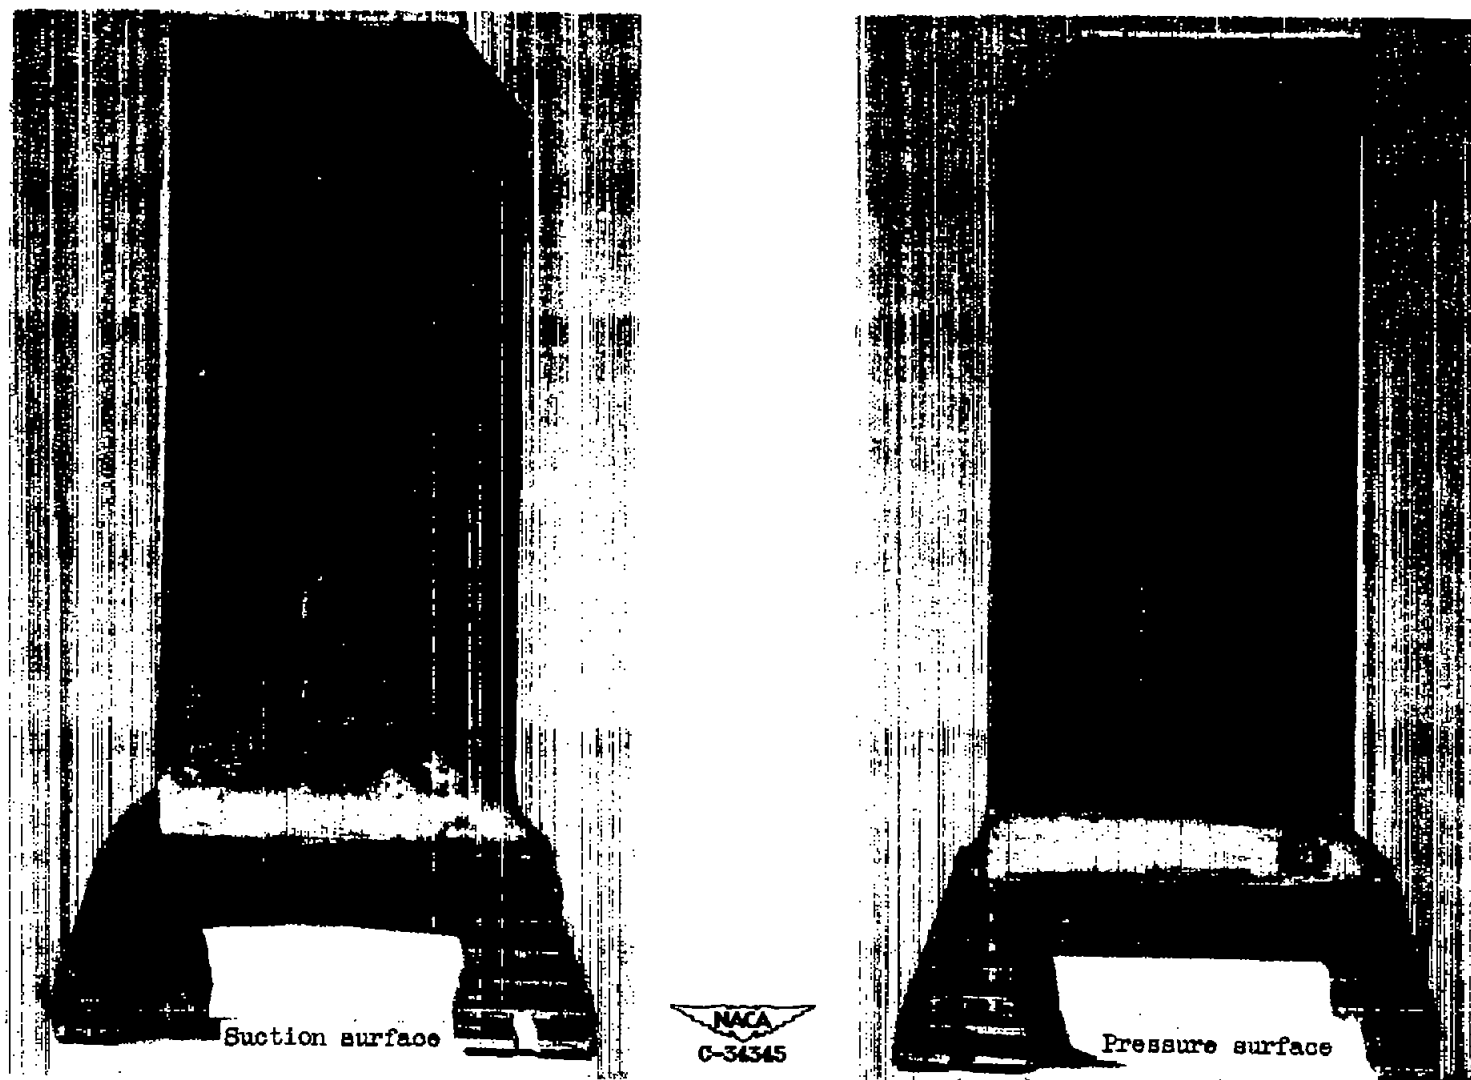
(b) Blade after 100 hours at rated test conditions with coolant-flow ratio of 0.048. Surfaces in excellent condition. Previously damaged areas shown on figure 7(a) indistinguishable from adjoining surfaces.

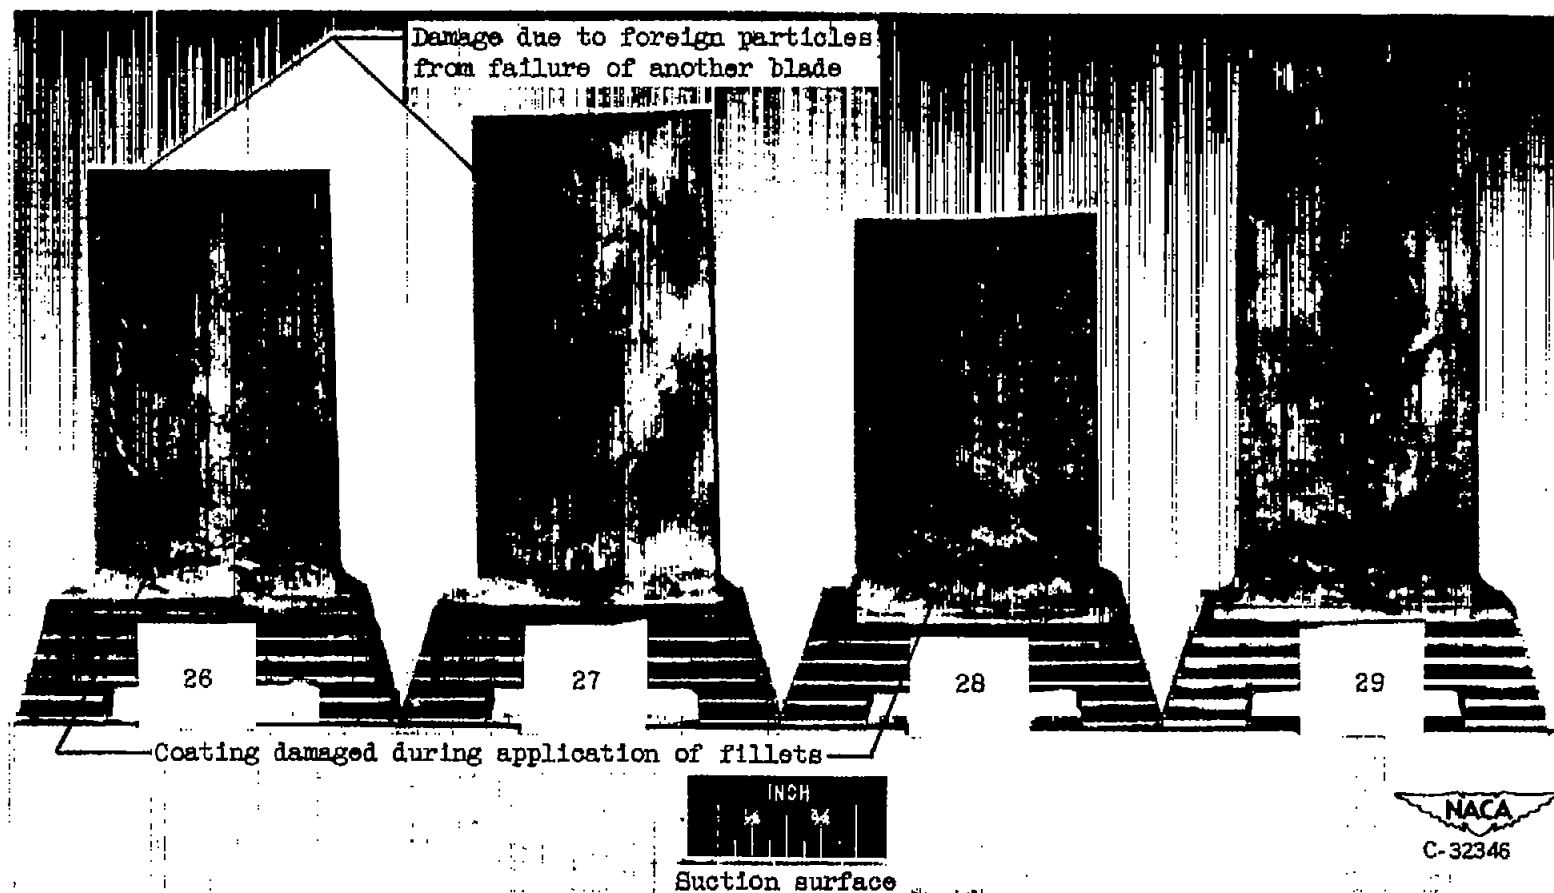
Figure 8(a) shows the suction surfaces of blades 26, 27, and 28 early in the investigation and of blade 29 prior to operation. Figure 8(b) shows both the pressure and suction surfaces of the blades at the completion of the investigation. Comparison of the suction surfaces shown in figures 8(a) and 8(b) indicates that there was little change in the condition of the coating on the blades, even though the blades of figure 8(b) have about 100 hours more operating time than in figure 8(a). With one exception, the entire surface of each blade including the leading- and trailing-edge regions, which were the first to exhibit failures on the ceramic and nickel coatings, was in excellent condition at the completion of the tests. Surface scratches and abrasions showed no tendency to progress and no corrosion developed in them as the investigation continued. The tip regions of blades 26 and 27 were damaged when struck by fragments of another blade, but the aluminized coatings continued to protect the surrounding areas. No corrosion was evident except on blade 27, where the metal was actually torn and the bare steel was exposed to the action of the gases.

(a) Blades during early stages of endurance running with coolant-flow ratio of 0.03. Time on blades 26 and 27, 23.8 hours; on blade 28, 18.1 hours; on blade 29, no time. Surfaces in excellent condition.
